Hydrology, Water Chemistry, and Vegetation Characteristics of a Tamarack Bog in Bath Township, Ohio: Towards Restoration and Enhancement¹

OHIO J SCI 105 (2):21–30, 2005

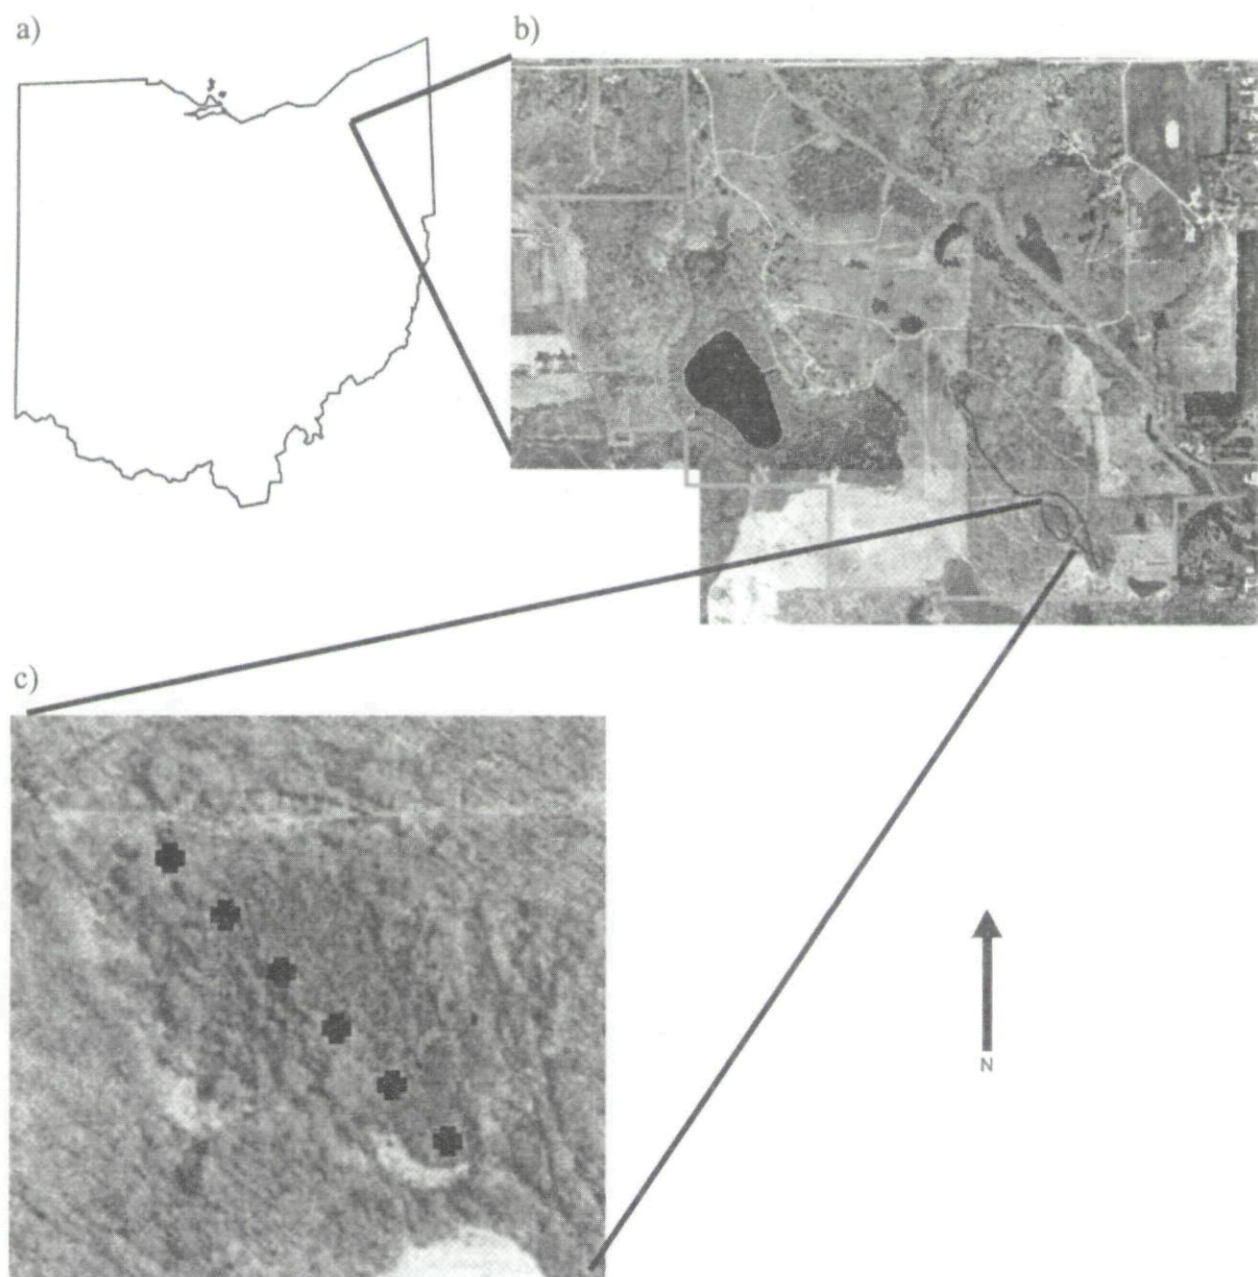
FIGURE 1. Location map of study site; where a) is Ohio, b) is the Bath Nature Preserve, and c) is the Tamarack Bog. The crosses in the Tamarack Bog represent the transect of water level wells located in the bog.

Bath Nature Preserve (BNP) is a 404-acre (163.62 ha) parcel located in the glaciated plateau of northeastern Ohio (Fig. 1a). The property (formerly part of tire manufacturer Raymond Firestone's country estate) is now owned by Bath Township, and preserves healthy examples of habitats such as open grasslands, mature mixed deciduous forests, wetlands, streams, and ponds. Notably, the preserve includes a tamarack bog, located

in the southeast section (Fig. 1b).

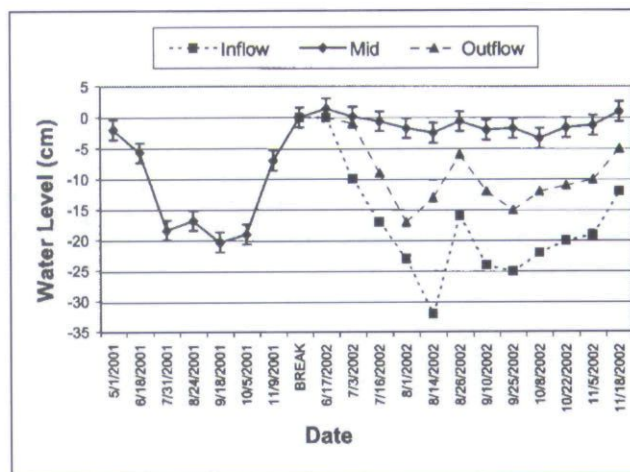
FIGURE 2. Water levels of the Bath Tamarack Bog. There is a break in the data between 9 November 2001 and 17 June 2002. The term "BREAK" on the x-axis refers to the break in data collection with respect to the middle of the bog. Error bars represent ± 1 standard error.

The hydrology of the bog center demonstrated more variance in the 2001 season than the 2002 season (Fig. 2). In 2001, the water levels of the middle fluctuated from a high of -2.0 cm to a low of -20.0 cm. In 2002, the

hydrology of the bog was more stable, ranging from $+2.0$ cm to -3.0 cm. The inflow and outflow both demonstrated high variance with the inflow being more severe. Inflow water levels ranged from 0.0 cm to -32.0 cm, while outflow levels ranged from 0.0 cm to -17.0 cm.

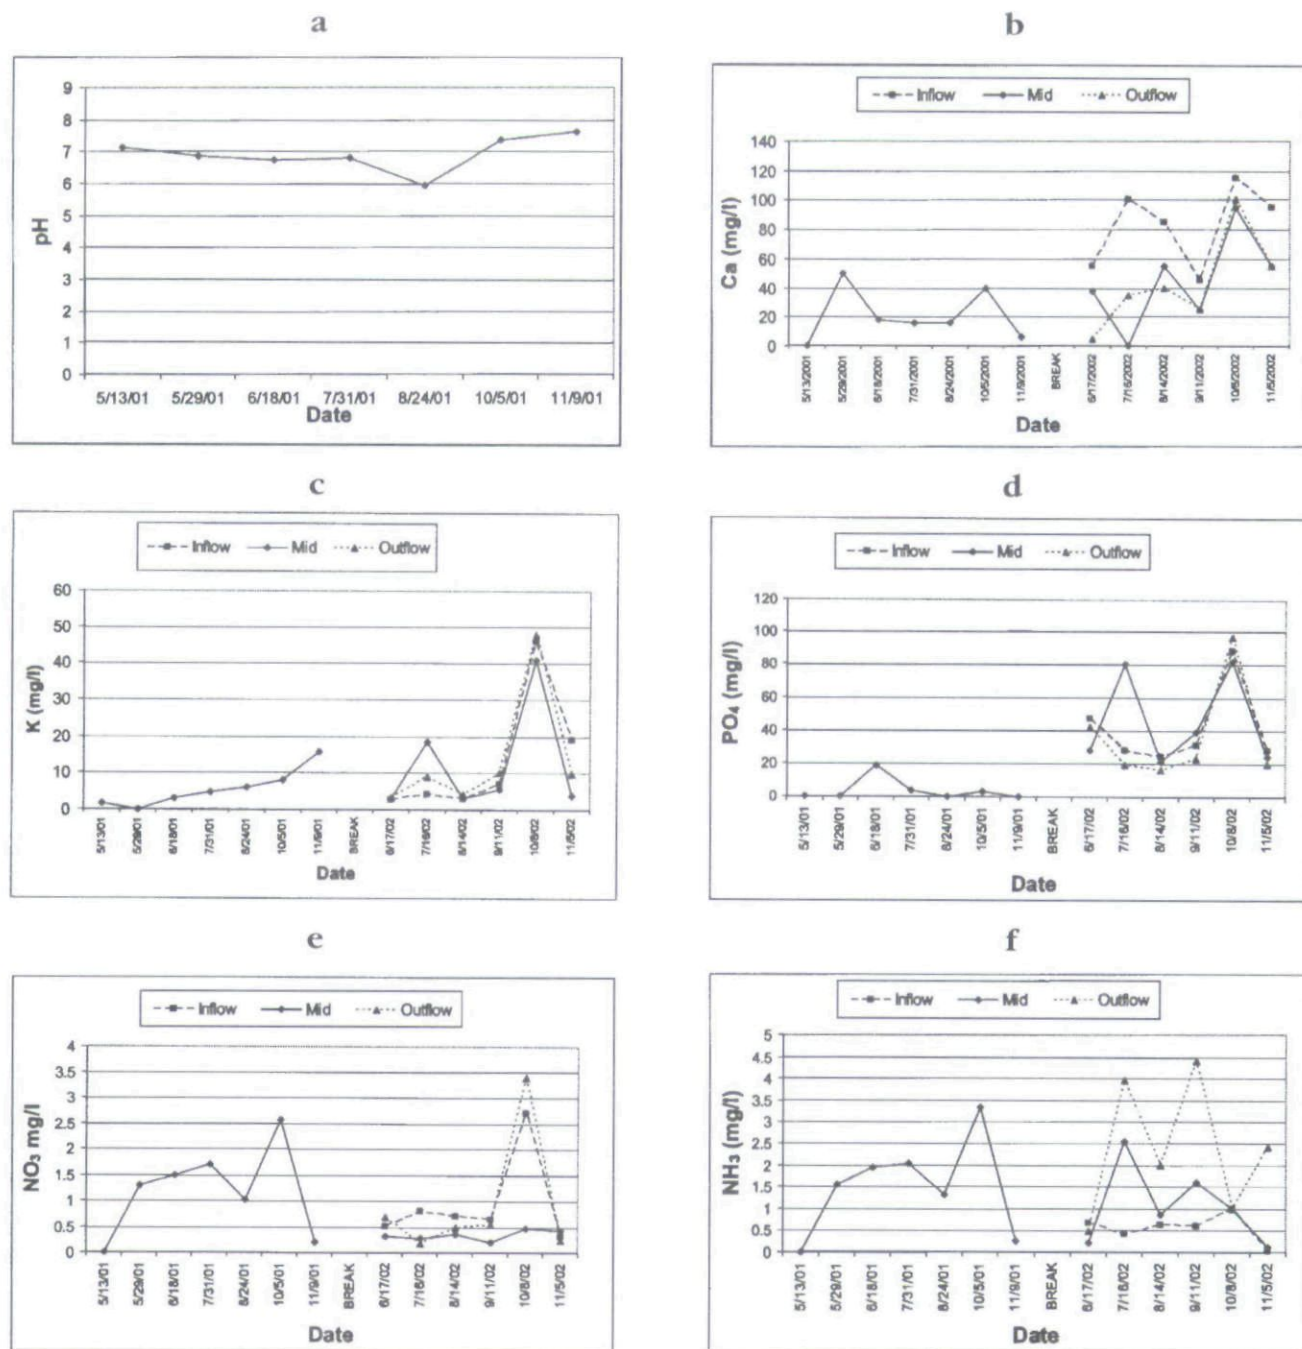
FIGURE 3. Water chemistry measurements; where a) is pH levels from the center of the Bath Tamarack Bog, b) is calcium levels, c) is potassium levels, d) is phosphate levels, e) is nitrate levels of the Bath Tamarack Bog, and f) is ammonia levels of the Bath Tamarack Bog. There is a break in the data between 9 November 2001 and 17 June 2002. The term "BREAK" on the x-axis refers to the break in data collection with respect to the middle of the bog.

The pH, calcium, potassium, phosphate, nitrate, and ammonia levels for 2001 and 2002 are detailed in Figure 3 (a–f). pH (Fig. 3a) shows little variation between May and November of 2001, but quite high values from 6.0 to 7.7. Calcium (Fig. 3b) tended to increase in the fall. Generally the inflow values were greater than mid- and outflow. Similar to calcium, potassium (Fig. 3c), phosphate (Fig. 3d), nitrate (Fig. 3e), and ammonia (Fig. 3f) had high values in October. The highest ammonia values were detected in the outflow (Fig. 3f).

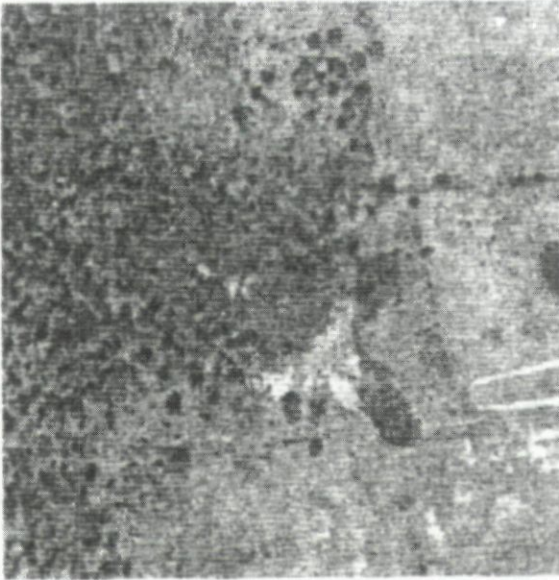
a. 1938

FIGURE 4. Aerial photographs of the Bath Tamarack Bog.

The 1938 aerial photograph of the bog, the oldest available, shows a bog of approximately 5.6 ha and provides evidence for standing water at the southeast end of the bog (Fig. 4a). Standing water is apparent in both the 1951 (Fig. 4b) and 1963 (Fig. 4c) photographs as well. In addition, gas lines appear to have been in-

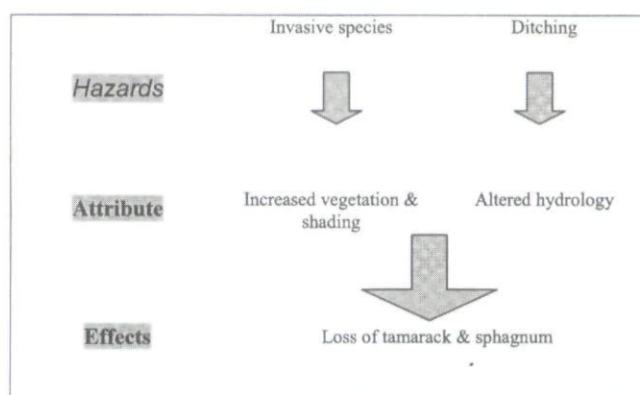
FIGURE 5. Hazards affecting the Bath Tamarack Bog.

Figure 5 shows the effects of the identified hazards on the bog. Invasive species and ditching have both contributed to the loss of tamarack and *Sphagnum* via changes in vegetation and hydrology. The goals of any restoration should be to increase the cover of sphagnum and the number of tamaracks in the bog. Further goals, such as a self-sustaining population of tamaracks may not be practical (NRC 2001).
